March 13, 2025  
Job No. 0153-393A-25

Re: Letter  
Geotechnical Evaluation Report Update and Observed Site Class Determination  
Spanish Fork Palmyra Meetinghouse  
2107 East Heritage Drive  
Spanish Fork, Utah 84660  
LDS Property Number: 501-4029

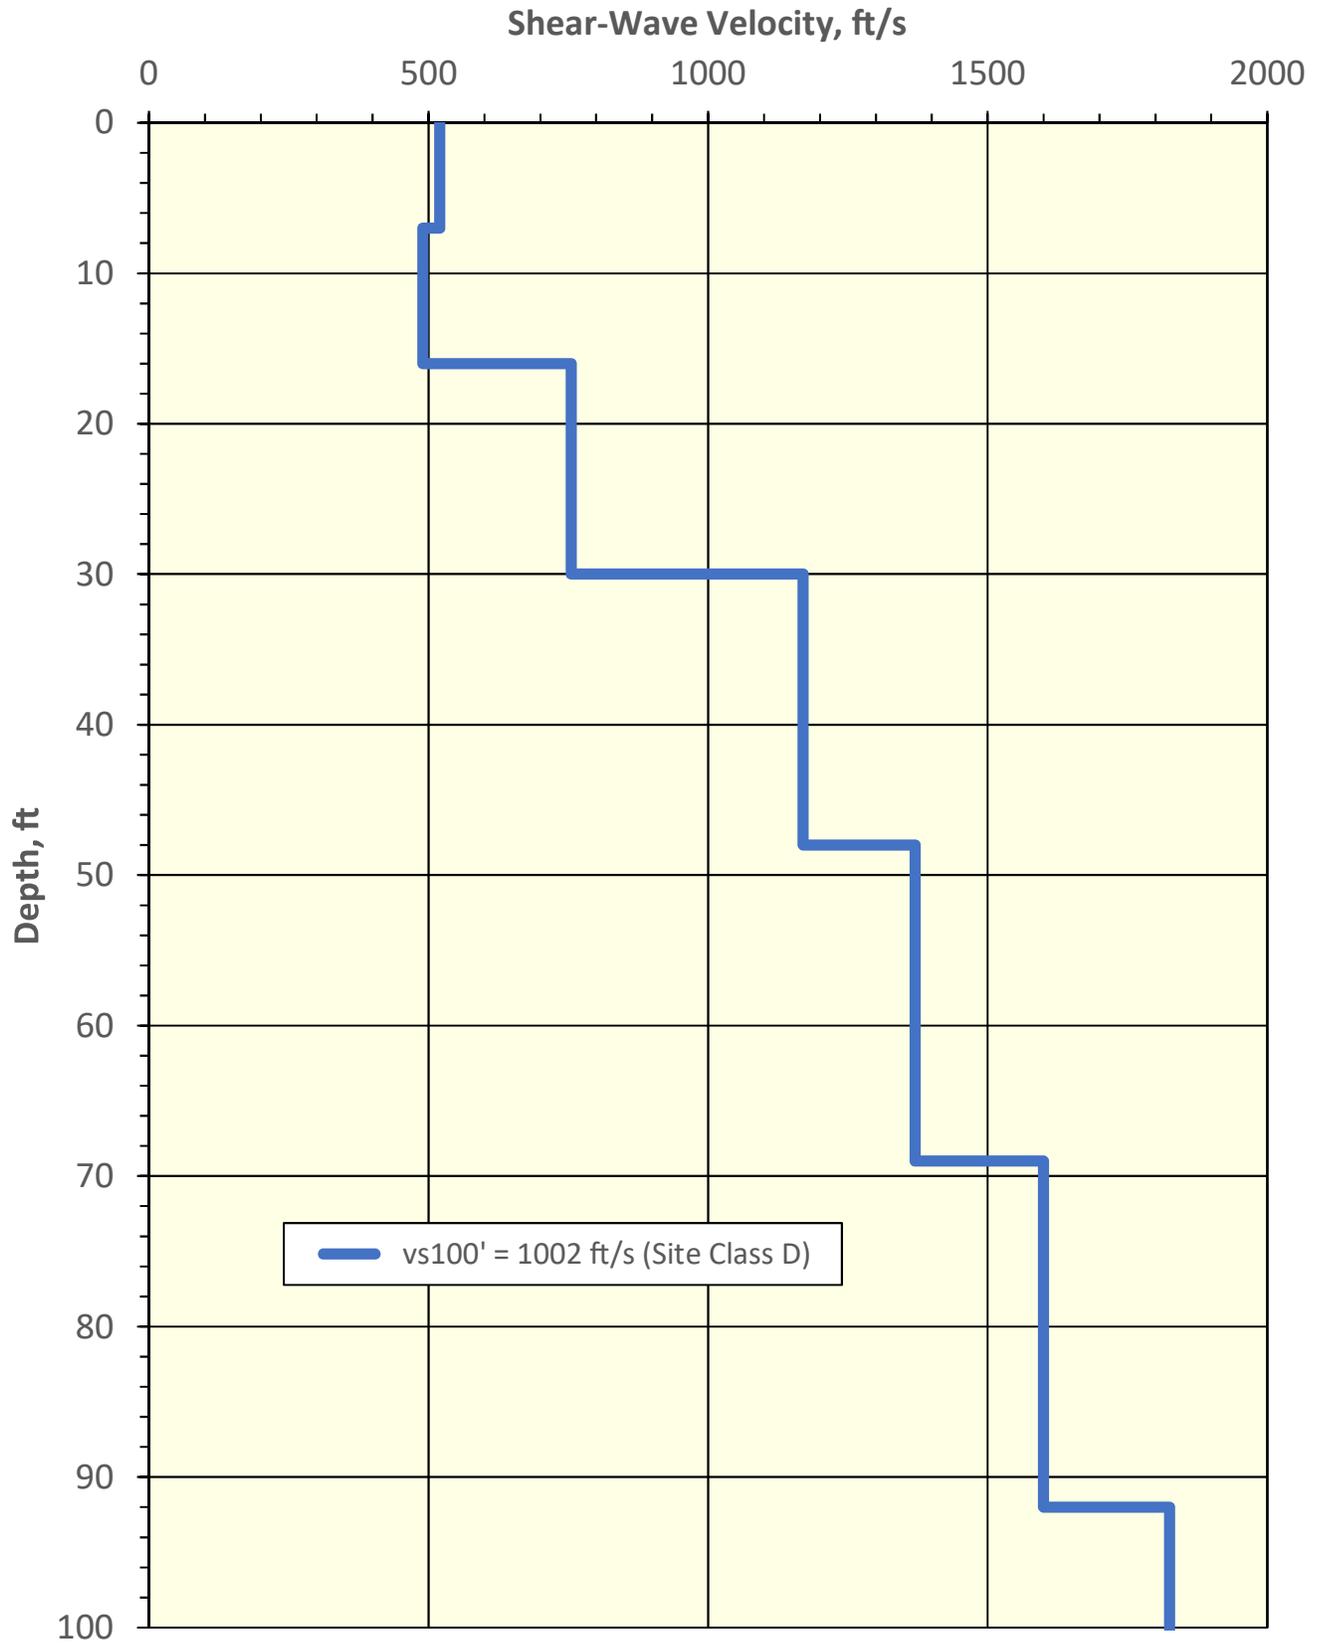
# SHEAR-WAVE VELOCITY PROFILE

The site shear-wave velocity profile was completed utilizing Refraction Microtremor (ReMi) testing. This geophysical testing was performed at the surface using a series of geophone sensors and a seismic source. A wavefield transformation was performed on the geophone recorded movements. The transformation was then utilized to create a shear-wave dispersion curve to model the subsurface shear-wave velocity profile.

The ReMi testing was analyzed with a resulting average shear-wave velocity in the upper 100 feet/30 meters ( $\bar{v}_{s30}$ ) of 1,002 ft/s. This characterizes the site as a Site Class D – Stiff Soil Profile as defined in Chapter 20 of ASCE 7-16.

The shear-wave velocity results are provided on Figure 1, Shear-Wave Velocity Profile.
